Dam ID: HI 00065
UPPER ANAHOLA

STATE OF HAWAII - DLNR
DAM SAFETY INSPECTION SHEET

Inspection Type: Dam Safety Inspection

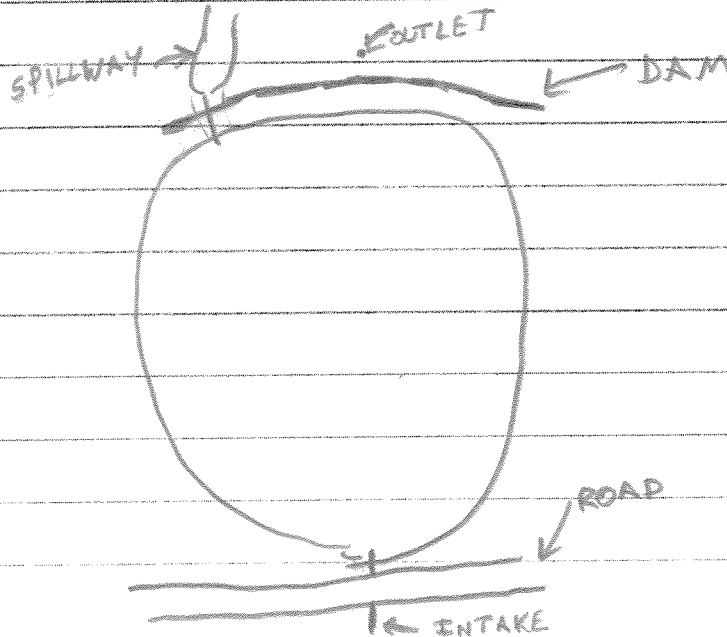
- INSPECTORS WERE TOLD RESERVOIR IS ABANDONED
- PROPER ABANDONMENT HAS NOT OCCURRED. DAM SHOULD BE BREACHED ^{TO BOTTOM OF RESERVOIR} TO ALLOW FOR PROPER ABANDONMENT.
- INTAKE PIPE SHOULD BE CLEANED TO PREVENT FLOWS FROM CONTINUING TO FLOW OVER ROAD. PIPE MAY NEED TO BE REPLACED W/LARGER PIPE TO ALLOW FOR PASSING OF DESIGN FLOWS.
- NO OUTLET WORKS CONTROLS WERE FOUND
